DISCO

DELIVERABLE D2.2 (version 1.0)

Failed fuel report: Characterisation and secondary alteration products

Author(s)/Editor(s): R.O'Neill, J.Goode, D.Hambley (National Nuclear Laboratory, UK)

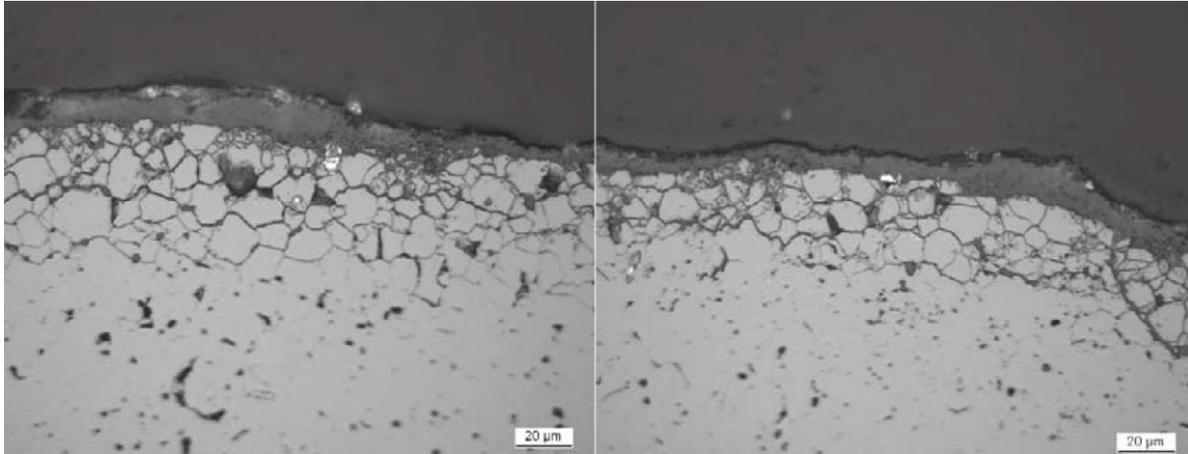
There is little reported post leaching examination of uranium dioxide fuel available. Of the available data, optical microscopy (Figure 1) suggests that enhanced leaching takes place at the fuel surface however this sample image was taken from a sample of fuel used in a controlled leaching trial and it is not entirely clear how representative it would be of fuel that had leached in actual conditions found inside a steel container. It was therefore felt that the WAGR fuel provided an opportunity to examine fuel which was more likely to represent the

Figure 1. A cross sectional image through an irradiated fuel fragment exposed to simulated ground water (Zwicky, Low, & Ekeroth, 2011).

- There is no significant difference in fuel microstructure today as compared with original PIE images (see Figure 20).
- The results contradict those seen in previous examinations of leached fuel however, it should be noted that the LWR fuel seen in Figure 1 was part of a controlled leaching study in known conditions and was also of significantly higher burn up than the WAGR fuel examined here.

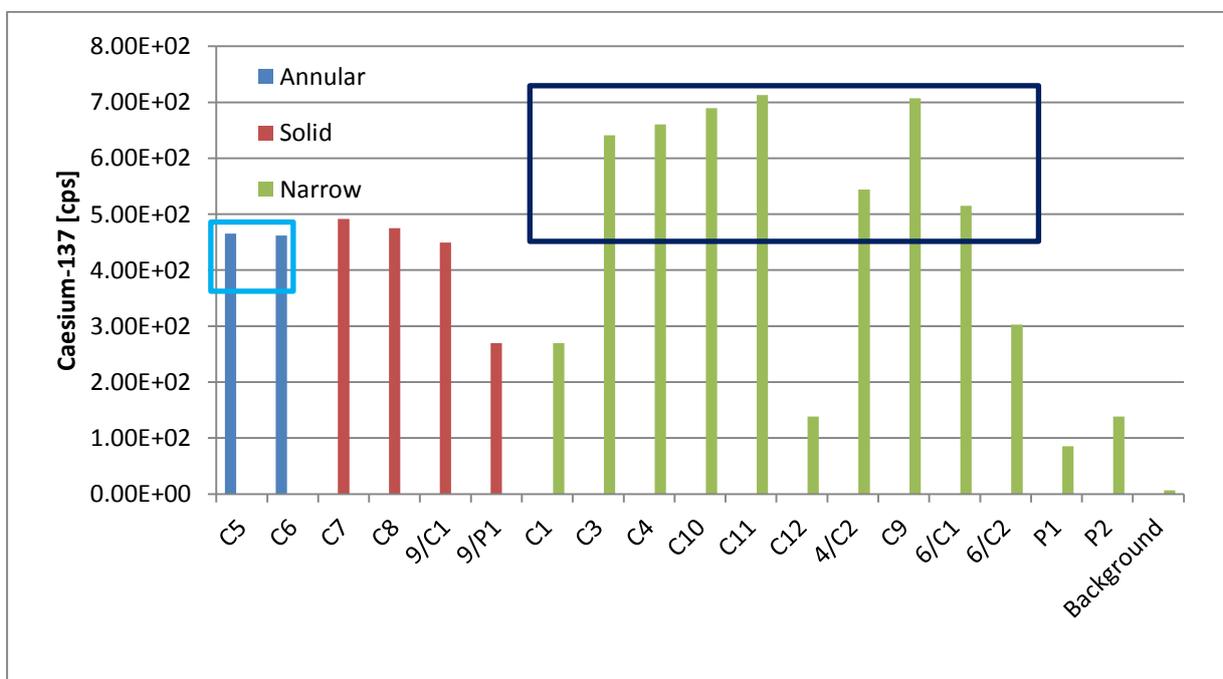
this fuel also contained remnants from an early IE 221B stringer which had a burnup of only $\sim 5 \text{ GWd.teU}^{-1}$ and was visually identical. Gamma spectroscopy was carried out to identify the high burnup fuel from 221B, the results of which are shown in Figure 2. The pins highlighted in dark blue are those from 221B/4.

The retained fuel included two annular sections with a hollow bore. A section of annular fuel was also selected for examination because a number of reactors, including the UK's Advanced Gas-cooled Reactors (AGRs) have annular fuel, and there is little data on annular fuel. Both sections of annular fuel were from irradiation experiment (IE) 424, stringer 4 (424/4) and had a low burnup of around 8.9 GWd.teU^{-1} . These sections of fuel are shown in the light blue box in Figure 2.

Figure 2. Spot gamma scan results for retained fuel pins

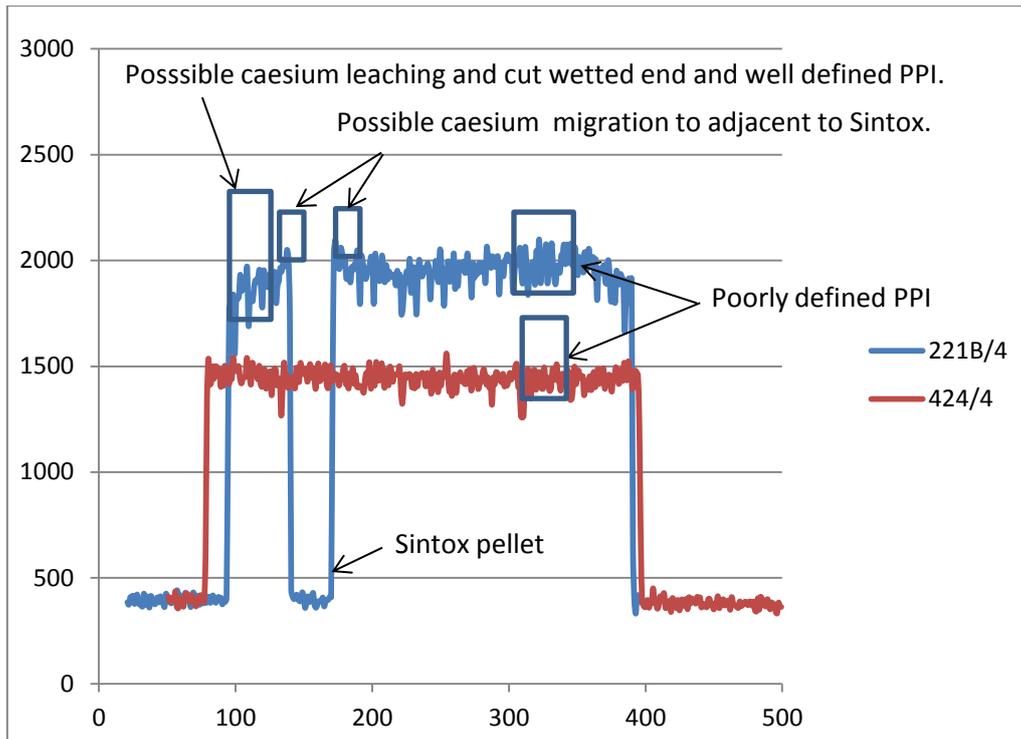
Axial gamma scans of the most promising candidate fuel sections were carried out to look for evidence of fuel that may have been leached or oxidised due to extended contact with pond water (e.g. Figure 3, region A) and to identify suitable positions for sample extraction. The gamma scans identified normal features expected in SNF, such as pellet-pellet interfaces (PPI) and insulator pellets. The gamma scan also indicates a decrease in caesium towards the ends of the solid fuel section from 221B/4, whereas that from the annular fuel section from 424/4 did not show a decrease in caesium at the ends. This is most likely to be due to the presence of an annulus, which allowed greater water penetration along the whole length of the fuel section pin leading to roughly equal axially leaching of caesium.

Figure 3. Axial gamma scan of pin sections examined.

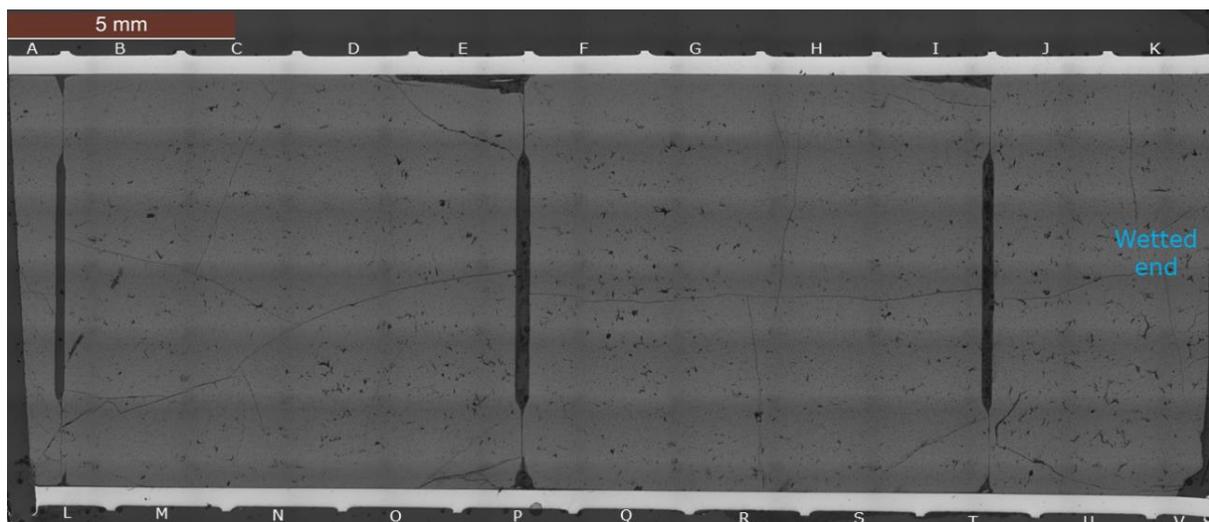
Figure 4 shows an overview of the solid fuel section, with the wetted end to the right of the image. The nominal outer dimension for this solid fuel sample is ~10.16 mm (0.4”).

Figure 4: A macrograph of IE 221B/4

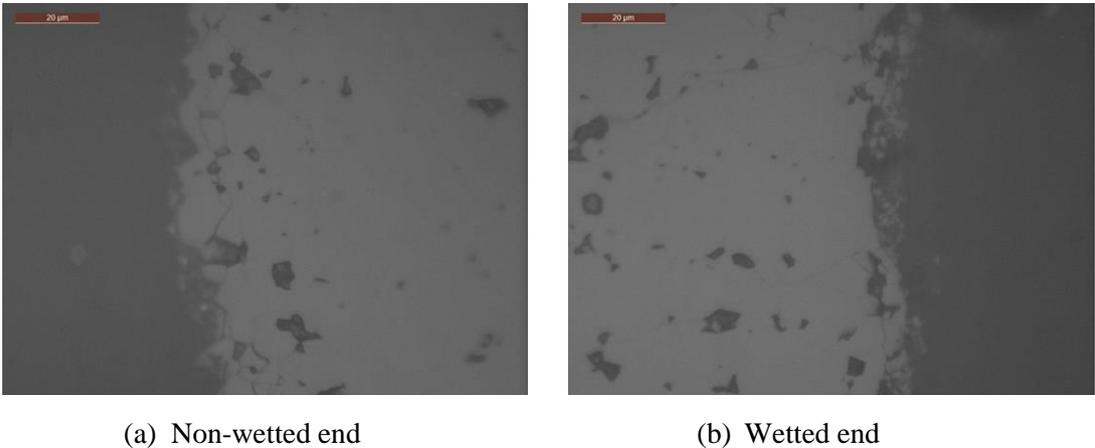
There appeared to be very little microstructural difference between the fuel at the wetted and non-wetted ends of the samples, as shown in more detail in Figure 5. No intergranular porosity was observed within the fuel of IE 221B/4. The grain size within this fuel is small making it somewhat difficult to differentiate between as-manufactured porosity and “pull out²” as a result of sample preparation.

There was no evidence of any higher oxides or corrosion products within the fuel, with particular attention paid to cooler edge regions of the fuel and areas where water exposure was more likely, such as the wetted end, fuel cracks, fuel-clad gap and the PPI regions.

Figure 5: As-polished condition of the ends of the fuel section from IE 221B/4

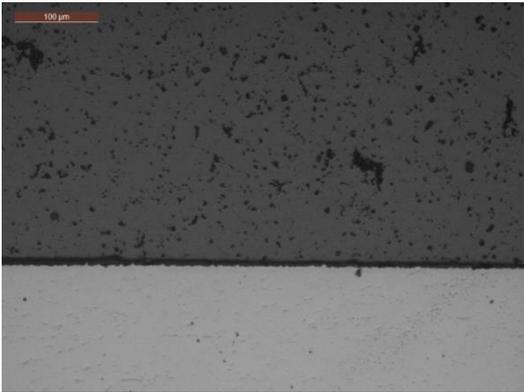
Examination of the cladding showed a continuous fuel-clad gap which matches with historic examination (Figure 6). The outer oxide layer appears to have been lost in all but one location at a rib root (Figure 7) and a similar observation was found for the carbon deposit.

Figure 6: As-polished micrograph showing the continuous fuel-clad gap found on 221B/4.

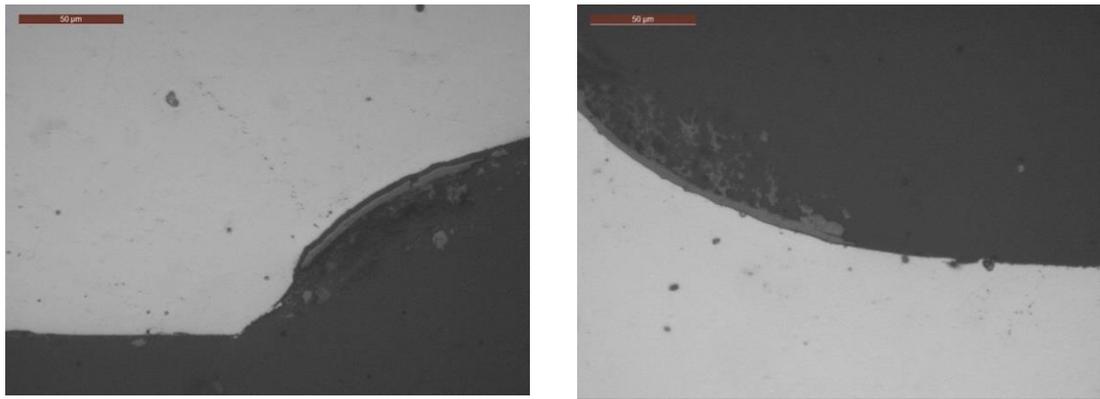
(a) Oxide

(b) Carbon deposit

Figure 7: Rib roots showing the remains of oxide and carbon deposit (221B/4).

- The oxide layer was almost entirely missing from the higher burnup sample, 221B/4.

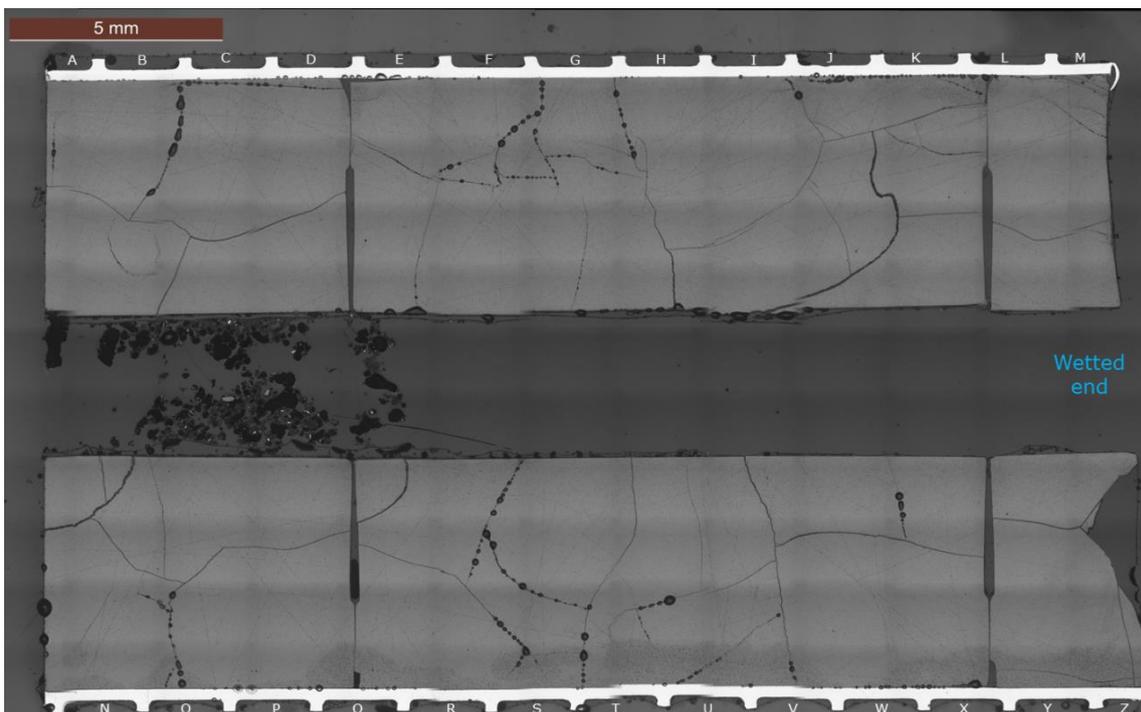
Figure 8 shows an overview of the sample from the end of IE 424/4 the nominal outer dimension for this annular sample is ~14.48 mm (0.57"). The black globules seen around the cracks are due to non-aqueous polishing media seeping out of the sample during examination.

Figure 8: A macrograph of IE 424/4

As can be seen in the macrograph of IE 424/4 (Figure 8) a piece of fuel appeared to be missing from the bottom fuel at the wetted end of the sample. Figure 12 shows as-polished micrographs of the region. There appears to be a large fuel crack running around this area. The high magnification micrographs (Figure 12 (b) and (c)) show there was plentiful intergranular porosity with some possibly interlinking. However the area of fuel exposed to the water and around the cracks showed no evidence of any fuel oxidation or loss of material.

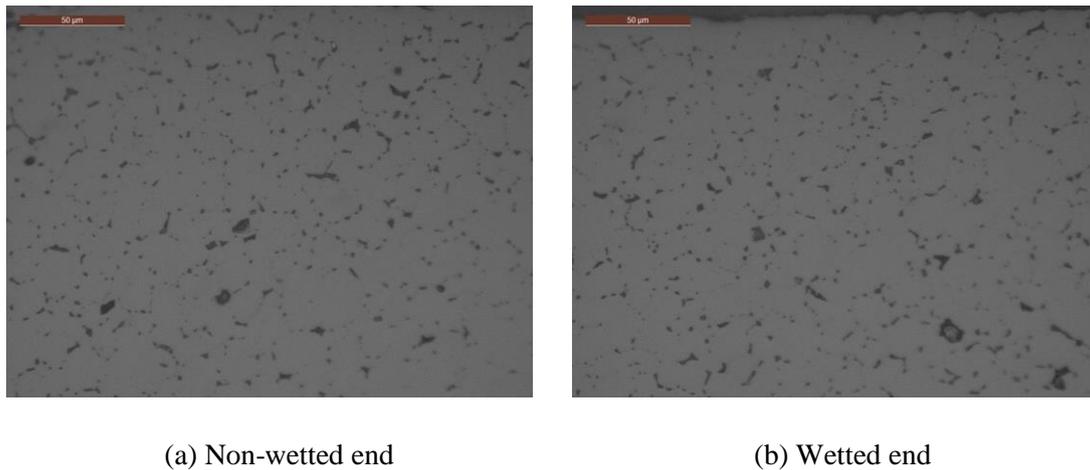
Intergranular porosity was observed within the fuel on either side of the bore and at both the wetted and non-wetted ends of IE 424/4 (Figure 9). No intragranular porosity was visible, which is not uncommon for fuel from WAGR. Large amounts of as-manufactured porosity were observed in the fuel near the clad. Towards the middle of the fuel this porosity appeared

Figure 9: As-polished micrographs showing the intergranular porosity within IE 424/4

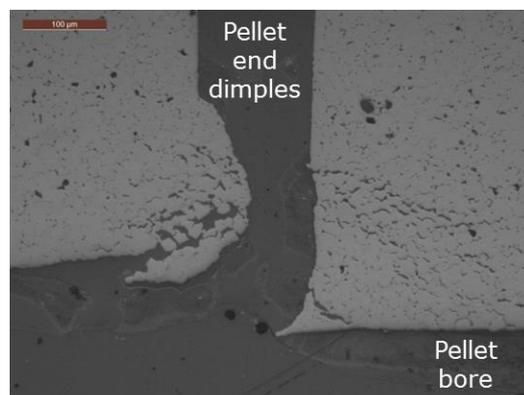
to have sintered up, with the development of intergranular porosity within the hotter regions of the fuel near the bore. Figure 10 shows higher magnification image of the near interlinkage of intergranular porosity within one dimple region at the pellet end. This is another potential pathway for the ingress of water.

Figure 10: IE 424/4 - As-polished micrograph of the swollen region of the dimple showing near interlinkage of intergranular porosity.

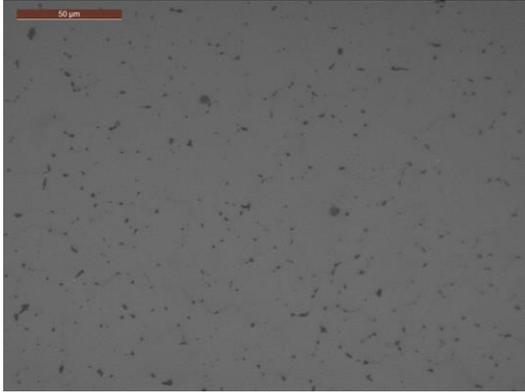
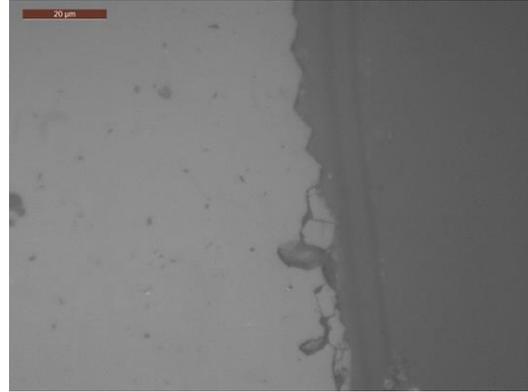
In the as-polished condition there appeared to be very little microstructural difference between the fuel at the wetted and non-wetted ends of the samples (Figure 11) and there was no evidence of any higher oxides or corrosion products within the fuel.

(a) Non-wetted end

(b) Wetted end

Figure 11: As-polished condition of the ends of the fuel section from IE 424/4.

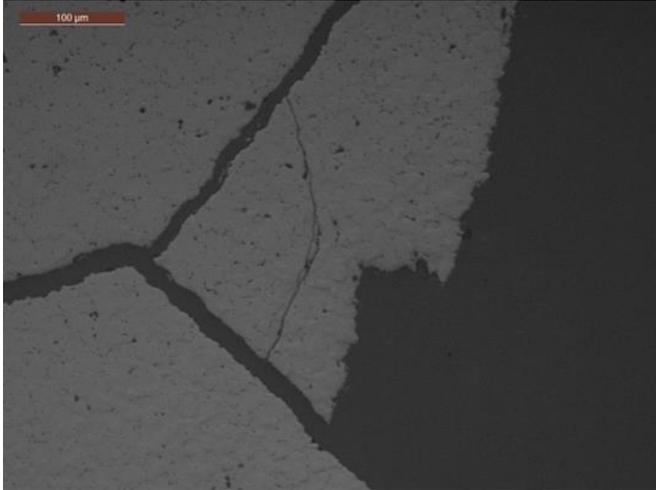
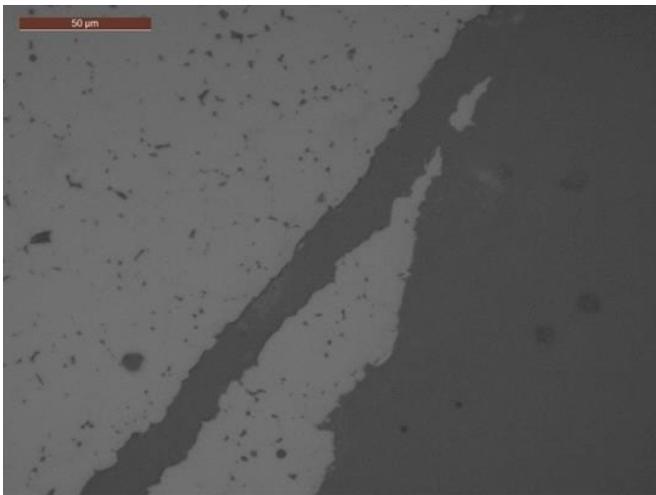
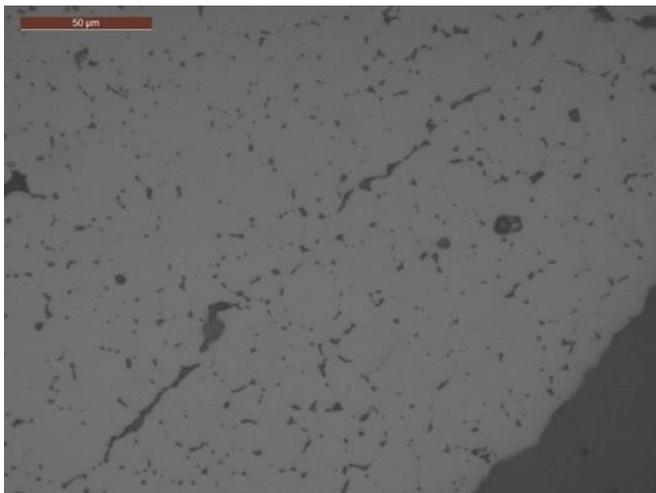
- a) Low power micrograph of the area adjacent to where the fuel is missing.

- b) High magnification of the area around the fuel crack.

- c) High magnification micrograph showing plentiful intergranular porosity, with some interlinking.

Figure 12: As-polished micrographs of the region around the missing fuel area at the wetted end of the fuel section from IE 424/4

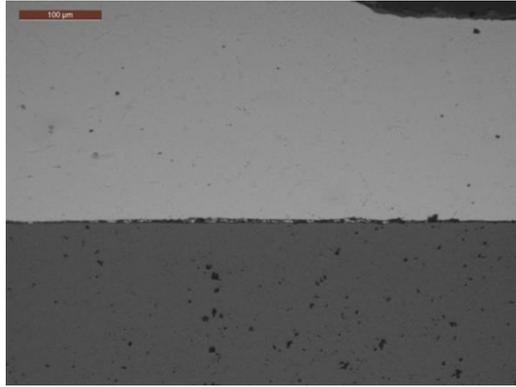
As with 221B/4, a fuel-clad gasp was found throughout 424/4 (Figure 13). However, unlike 221B/4, the cladding oxide layer had been retained, although was found to have lifted in places (Figure 14). Minor intergranular attack (IGA) was noted in places (Figure 15) but is consistent with non-penetrating surface corrosion associated with silicon intrusions.

Figure 13: As polished image showing the fuel-clad gap in 424/4.

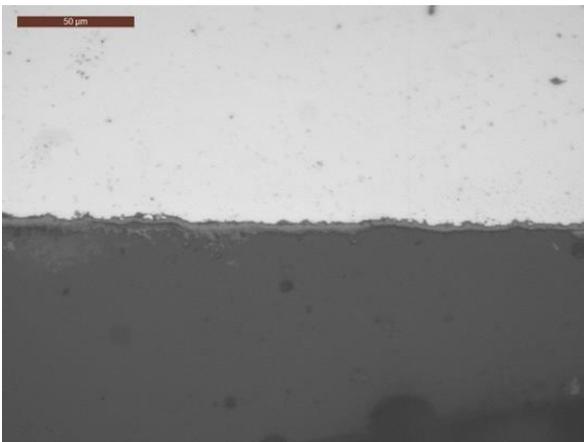
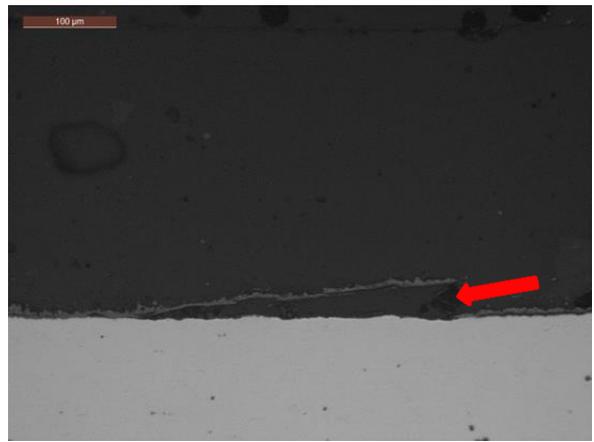
(a) Typical clad outer surface oxide layer

(b) Area where the oxide layer had lifted.

Figure 14: As-polished micrographs showing the condition of the outer surface oxide layer around IE 424/4.

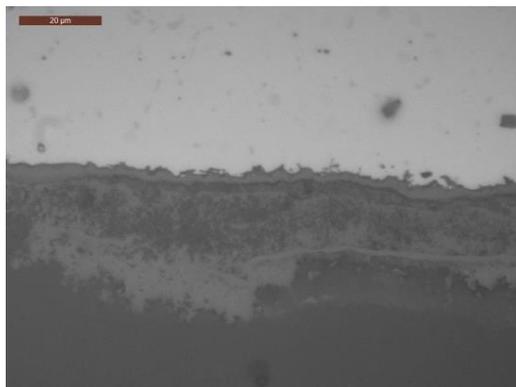
Figure 15: As-polished image showing limited IGA in 424/4.

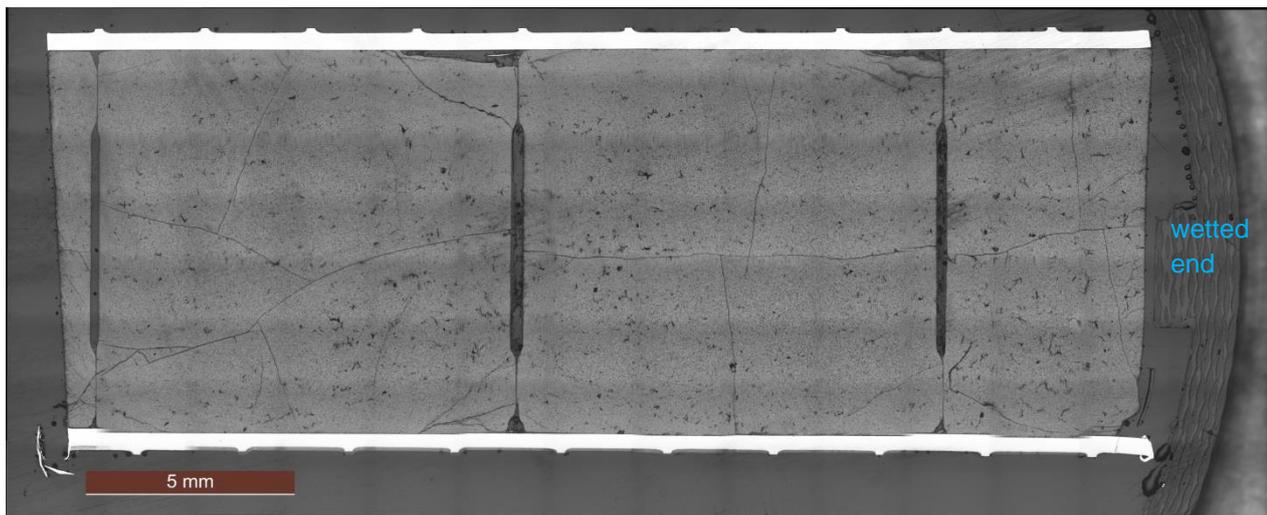
A macrograph of the fuel etched sample 221B/4 is shown in Figure 16. During the examination particular attention was paid to areas where water was potentially more likely to penetrate, i.e. in the fuel-clad gap, PPI regions and fuel cracks.

Figure 16. Macrograph of sample 221B/4 following etching

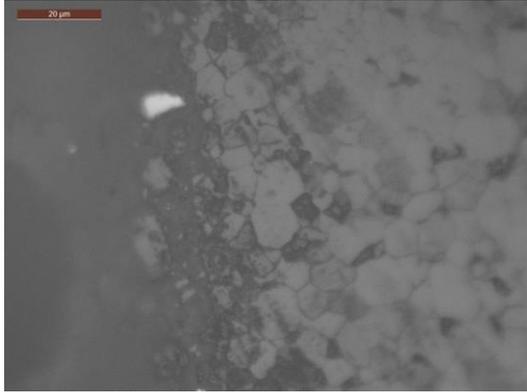
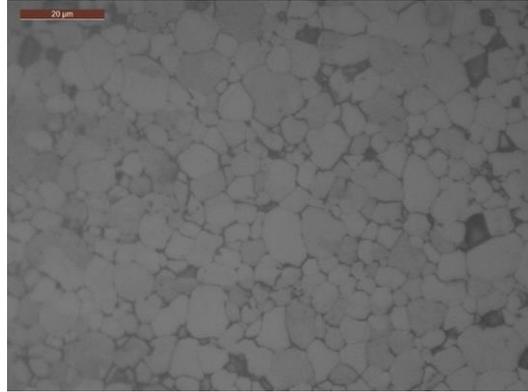
Figure 17 shows the fuel at the non-wetted end of the sample; this should represent the fuel structures most like the original sample (>40 years ago).

(a) Fuel surface

(b) Bulk fuel microstructure

Figure 17: IE 221B/4 – Etched micrographs of the fuel at the non-wetted end of the sample

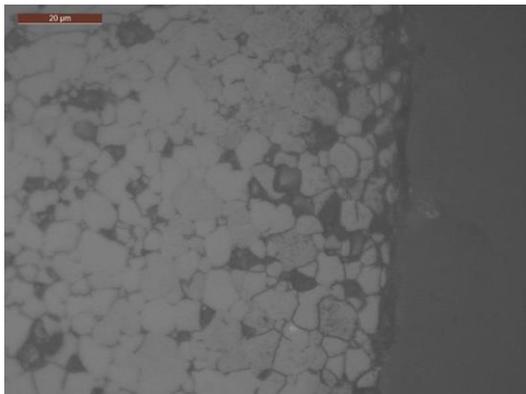
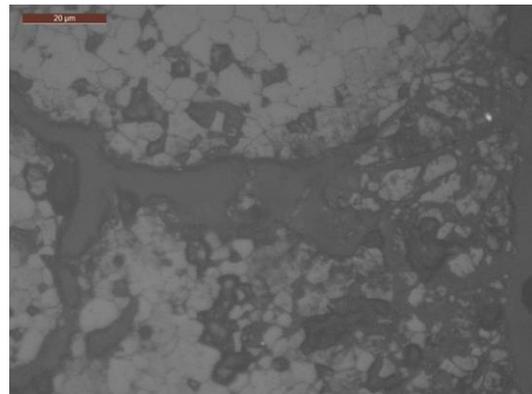
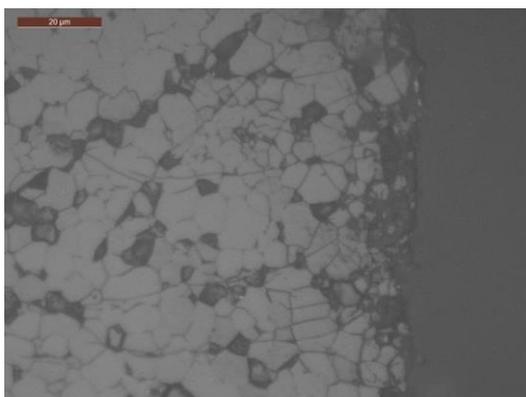
Figure 18 shows the fuel at the wetted end of the sample, including areas of cracking and microcracking which originate at the wetted fuel end. Comparing Figure 17 to Figure 17 (non-wetted fuel) there is no obvious difference within the fuel between the two ends. They also show that there was no discernible microstructural evidence of fuel oxidation both at the wetted end and within the fuel around these cracks.

(a) Fuel surface

(b) Sintering defect

(c) Microcracks running from the wetted surface

Figure 18: IE 221B/4 – Fuel etched micrographs showing the fuel at the wetted edge of the sample.

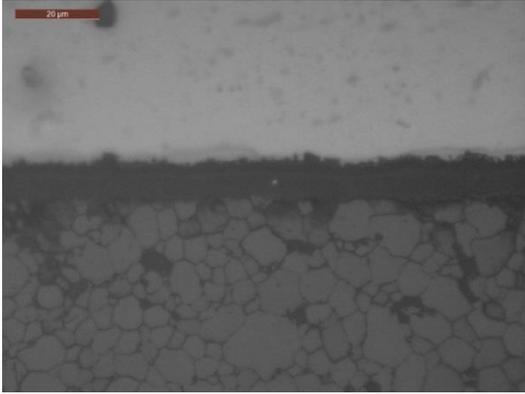
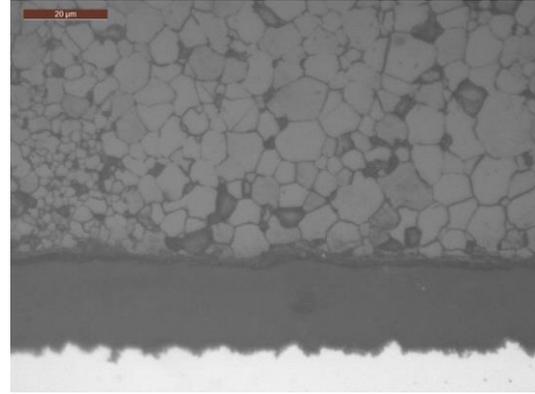
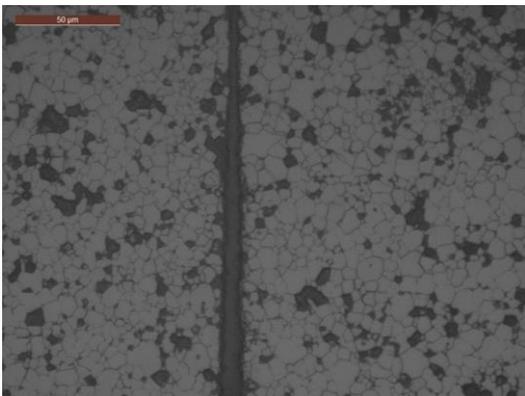
An example of the fuel adjacent to the fuel-clad gap on both the top and bottom sides of the samples is shown in Figure 19(a) and (b). Figure 19 (c) shows the region around the PPI within rib space T (see Figure 4), near the wetted end of the sample. As these micrographs show, there is very little evidence of any microstructural changes within the fuel along the fuel-clad gap or at the PPI.

(a) Fuel-clad gap at the top of the sample

(b) Fuel-clad gap at the bottom of the sample

(c) Fuel around the PPI

Figure 19: IE 221B/4 – Fuel etched micrographs of regions susceptible to the ingress of water.

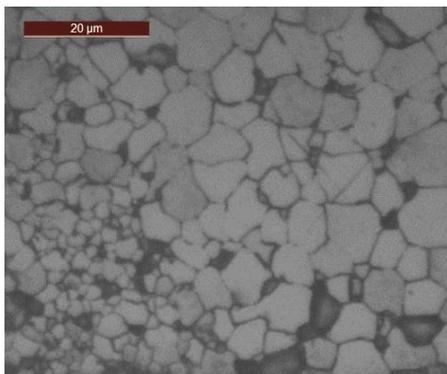
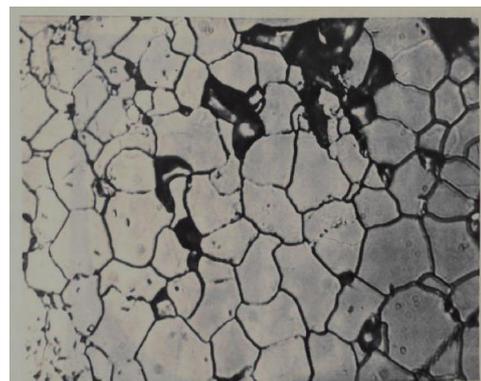
Figure 20 provides a comparison between the fuel microstructure in the current investigation and that reported in the original PIE (Nairn, Skinner, & Bradshaw, 1970). There is clearly no significant change observable at this level of resolution.

(a) Current

(b) 1960's

Figure 20. Comparison of recent and historic ((Nairn, Skinner, & Bradshaw, 1970)) examinations of the fuel microstructure.

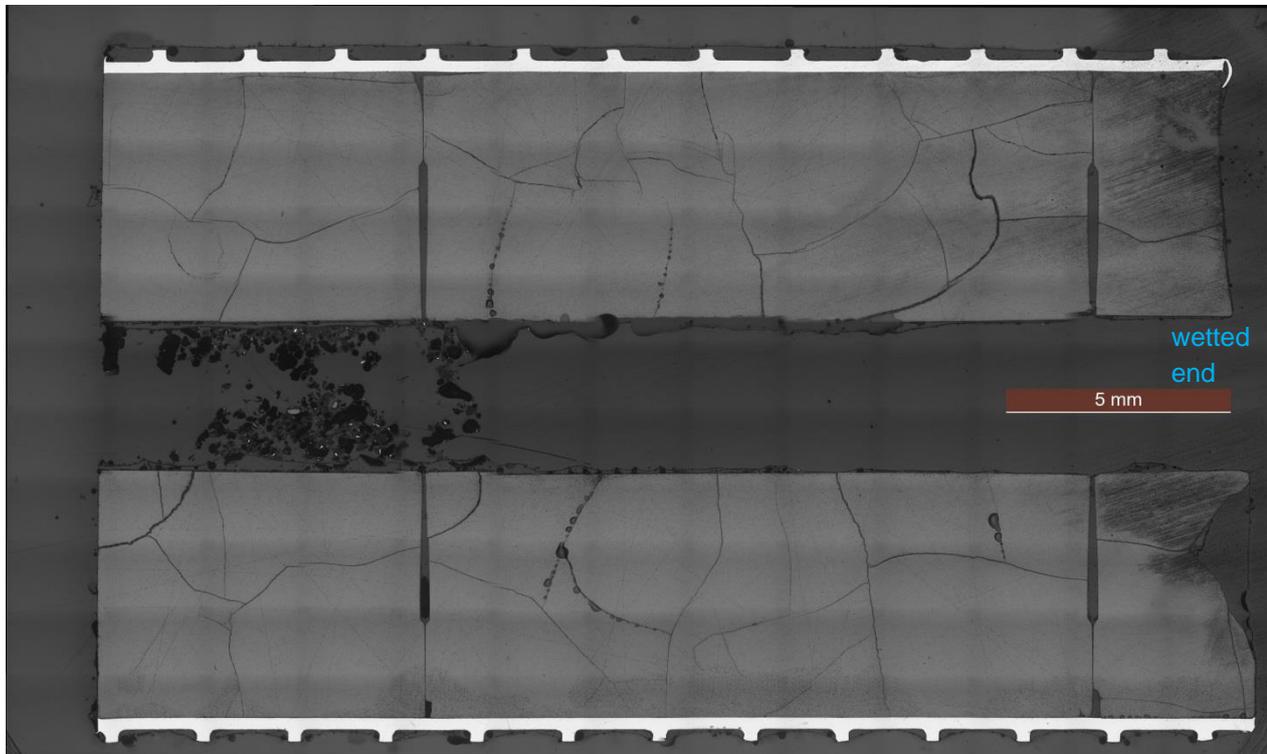
In IE 424/4 the bore provides another route for water to migrate freely through the sample, allowing rapid access to the PPI's, fuel-clad gap and fuel cracks throughout the fuel stack. Therefore during the examination particular attention was paid to these regions. A macrograph of the sample following the fuel etch is shown in Figure 21.

Figure 21. Macrograph of sample 424/4 following etching

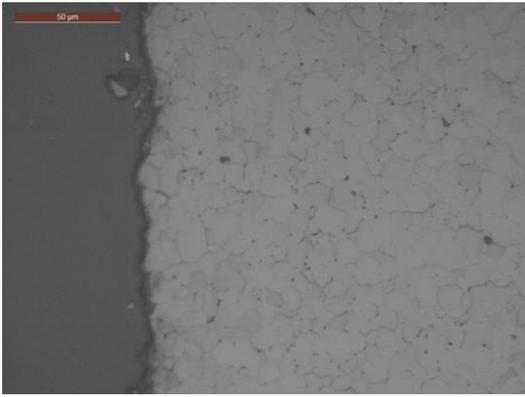
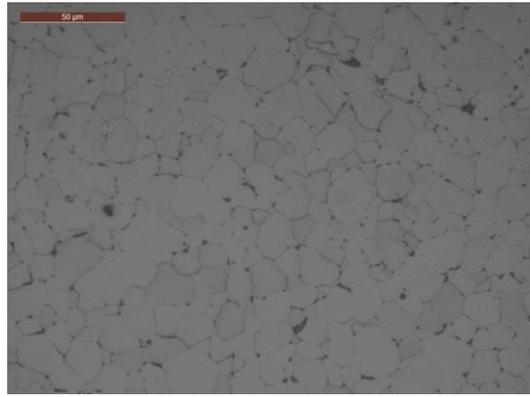
Figure 22 shows the fuel at the non-wetted end of IE 424/4 and Figure 23 shows the fuel at the wetted end. When examining both these regions there was little evidence of any microstructural differences and also no evidence of any fuel oxidation.

Figure 22: IE 424/4 – Etched micrographs of the fuel at the non-wetted end.

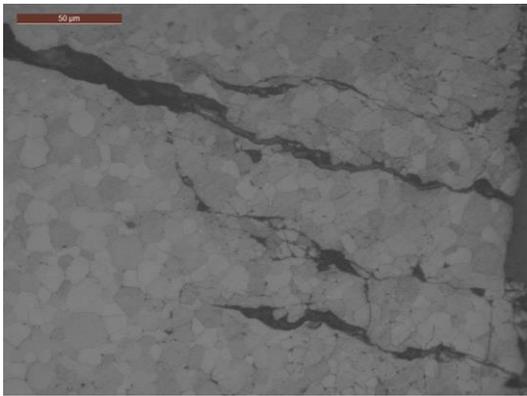
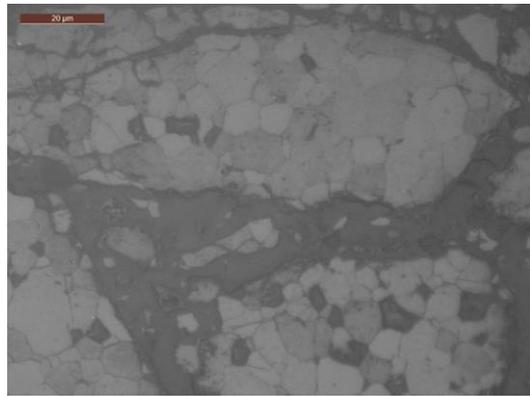
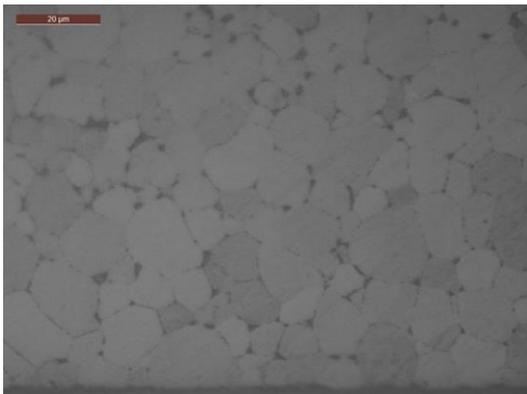
(a) Fuel cracking

(b) Fuel near the clad at the top of the sample

(c) Intergranular porosity

Figure 23: IE 424/4 – Etched micrographs of the fuel at the wetted end.

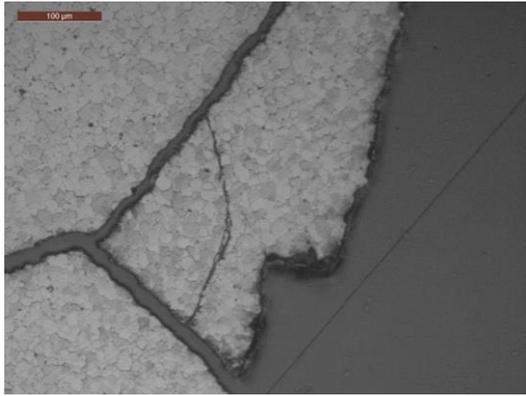
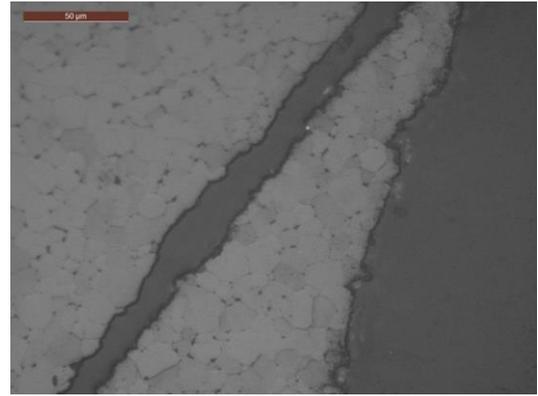
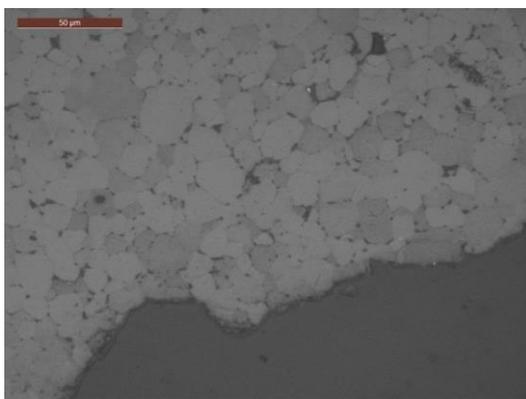
Figure 24 shows fuel etched micrographs of the area where the fuel was missing at the wetted end of the sample. These micrographs show that there was fuel cracking and intergranular porosity around this region. However there was no evidence of any microstructural differences within this region compared to areas of fuel around the rest of the sample.

(a) Overview of the area next to where the fuel was missing

(b) Fuel crack within the region where the fuel was missing

(c) Intergranular porosity within the fuel

Figure 24: IE 424/4 – Etched micrographs around the missing fuel region, at the wetted end.

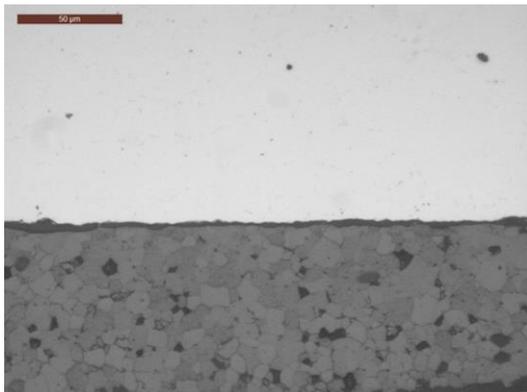
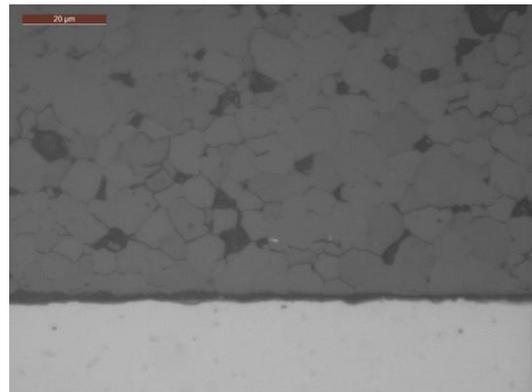
Particular attention was paid to the fuel next to the fuel-clad gap (Figure 25), around the PPI regions (Figure 26), on either side of the bore and also around the fuel cracks. As the images show, there was no obvious fuel oxidation within these fuel regions or any evidence of any microstructural changes.

(a) Top side

(b) High magnification of the fuel at the bottom side

Figure 25: IE 424/4 – Etched micrographs showing the fuel condition around along the fuel-clad gap.

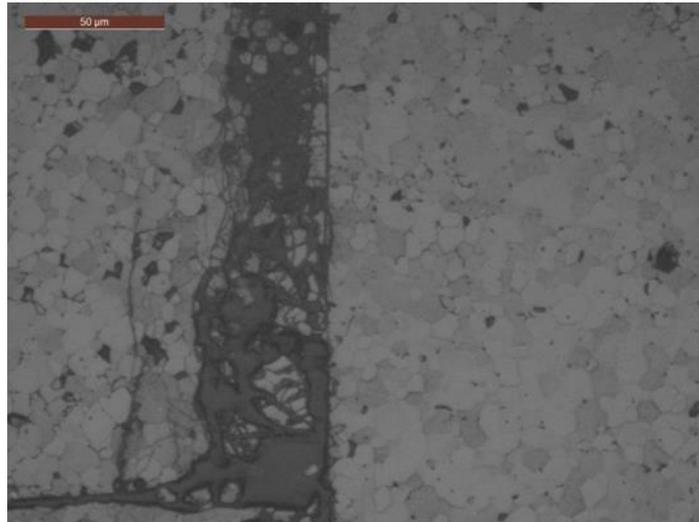
Figure 26: IE 424/4 – Etched micrograph of the PPI within rib space L.

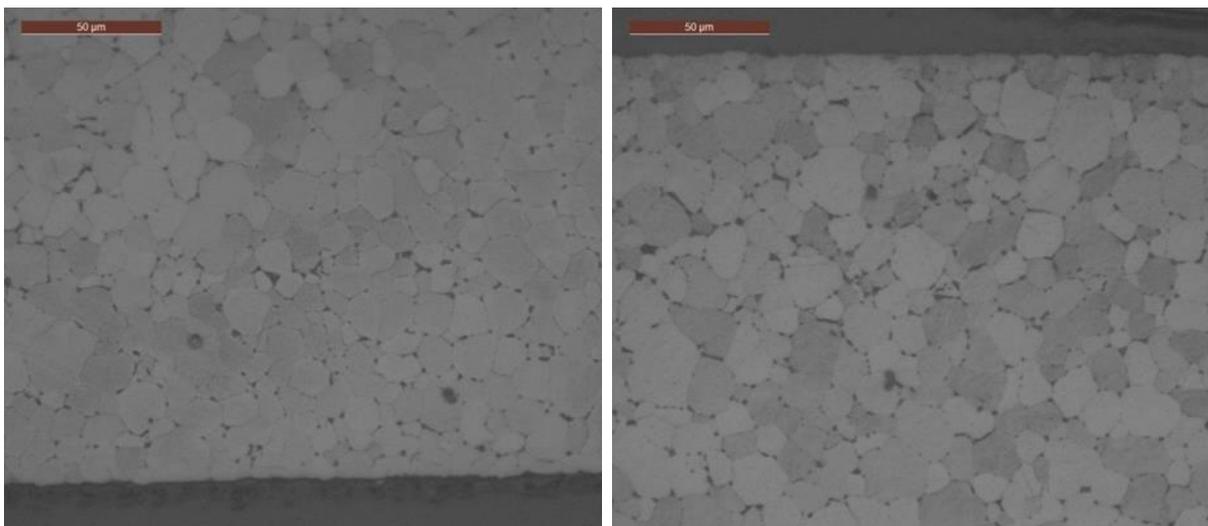
The intergranular porosity within the fuel around the bore region was continuous along the fuel from the wetted end to the non-wetted end. As mentioned in the as-polished observations, interlinked intergranular porosity was observed at the dimple within rib space L (see Figure 8). Figure 28 shows this region in the etched condition. As can be seen, this interlinkage could provide another possible pathway of water ingress to the fuel. Examinations around this area show no obvious signs of fuel oxidation.

a) Top side

b) Bottom side

Figure 27: IE 424/4 – Etched micrographs showing the fuel condition around the bore.

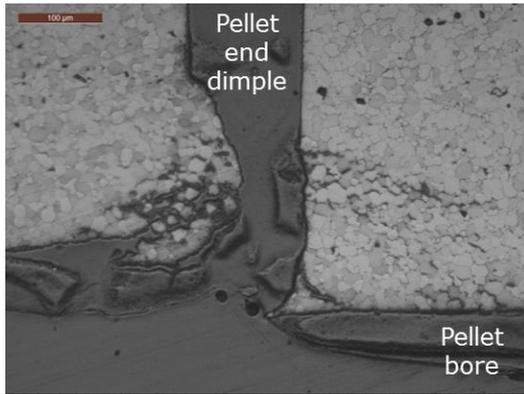
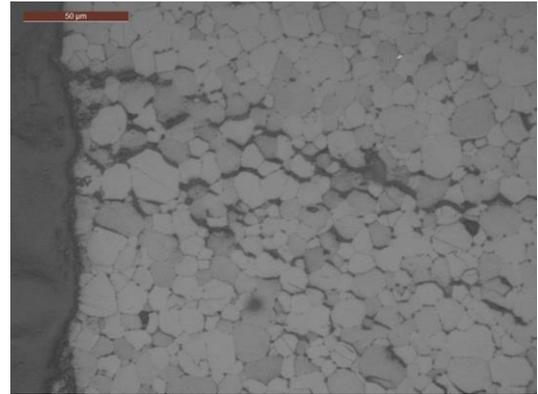
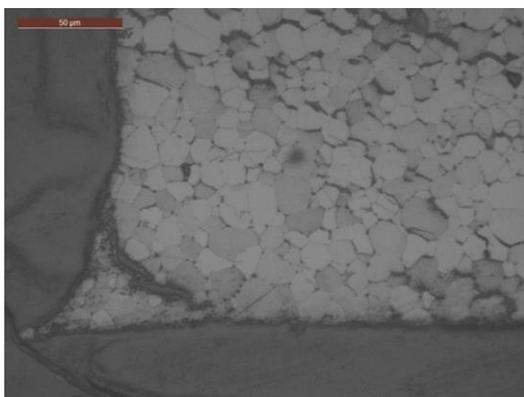
(a) Overview of the swelled dimple at the PPI/bore

(b) Interlinked intergranular porosity

(c) Interlinked intergranular porosity

Figure 28: IE 424/4 – Fuel etched micrographs showing the interlinked intergranular porosity at the dimple.
